SUBJECT: LEAD RISK ASSESSMENT AND MOLD  
SURVEY FOR HONOLULU HALE

The enclosed subject report, dated February 24, 2012, prepared by Muranaka Environmental Consultants, Inc., has been accomplished and is transmitted for your information and use. This report does not include the Department of the Corporation Counsel which was covered in a separate report.

Photo Log  
Honolulu Hale  
Lead Paint Risk Assessment and Mold Investigation  
MEC Project No.: 2011-0044  
July 2011

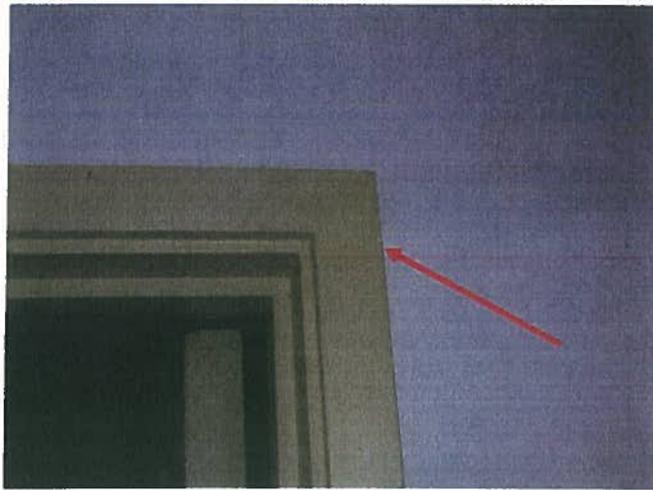
Photo No. 1:  
Evidence of mold growth on the wall, door and doorframe in the Custodian and Maintenance Office Area in the Basement. Similar evidence of mold growth was observed in various areas of the basement.

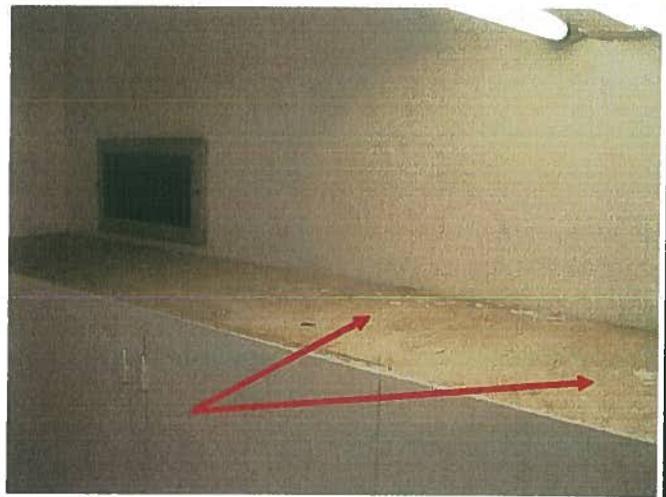
Photo No. 2:  
View of paint chips on the wall mounted cabinets in the Custodian's Office. Similar conditions were observed on air conditioning duct work, shelving, and cabinets throughout the basement.

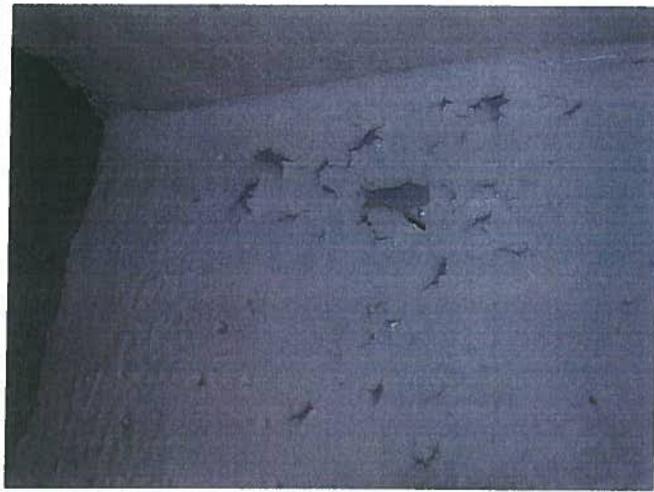
Photo No. 3:  
View of flaking paint on the wall in the hallway at the Custodian and Maintenance Office area. Flaking paint was observed at various locations throughout the basement.

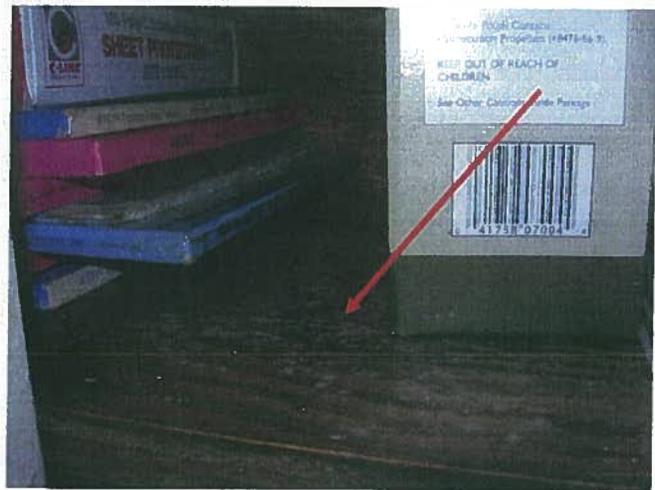
Photo No. 4:  
Evidence of mold growth on the shelving in the Maintenance Office. Similar conditions were observed on wooden shelves at various locations throughout the basement.

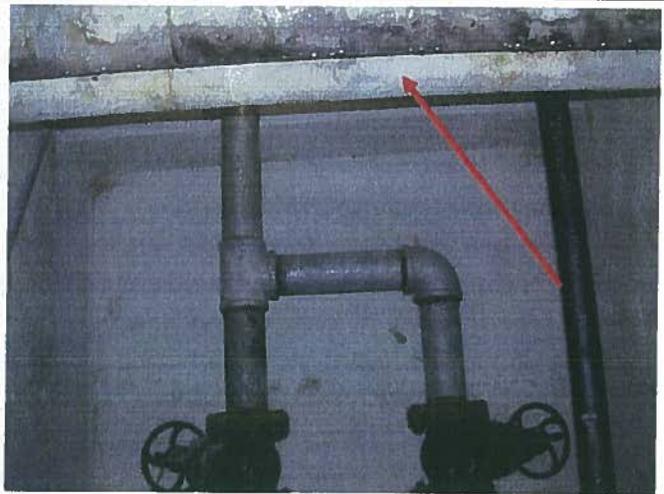
Photo No. 7:  
Evidence of mold growth on the pipe insulation in the pump room located in air handler room #2. Similar mold growth was observed on pipe insulation in the other air handler rooms in the basement.

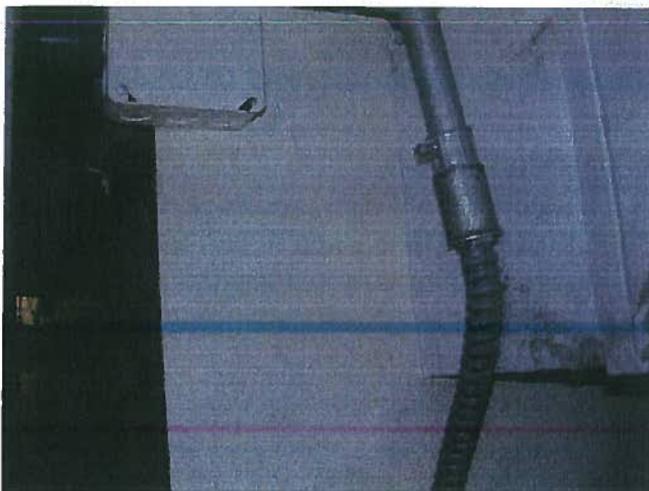
Photo No. 8:  
Evidence of mold growth on the wall in air handler room #1. Similar mold growth was observed at various locations throughout the basement areas.

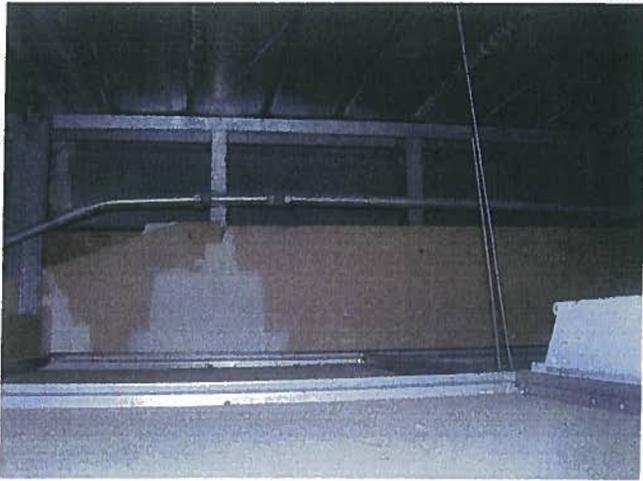
Photo No. 9:  
View of the bare metal ceiling above the ceiling grid in Office 100-City Clerk, Administration, Election.

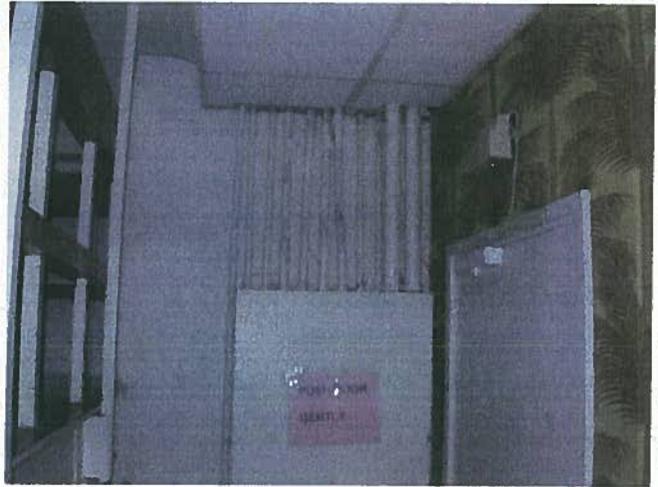
Photo No. 10:  
View of flaking paint on the conduit above the electrical panel in the Office 100-City Clerk, Administration, Election.

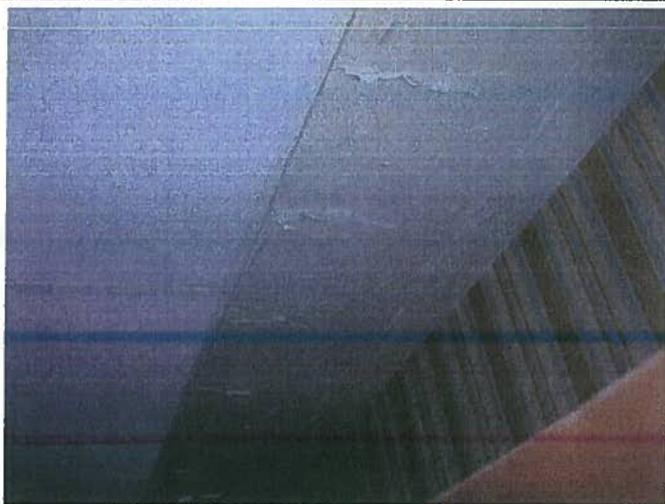
Photo No. 11:  
View of flaking paint on a concrete beam in Office D100. Similar flaking paint was observed at various locations throughout the Ground Floor.

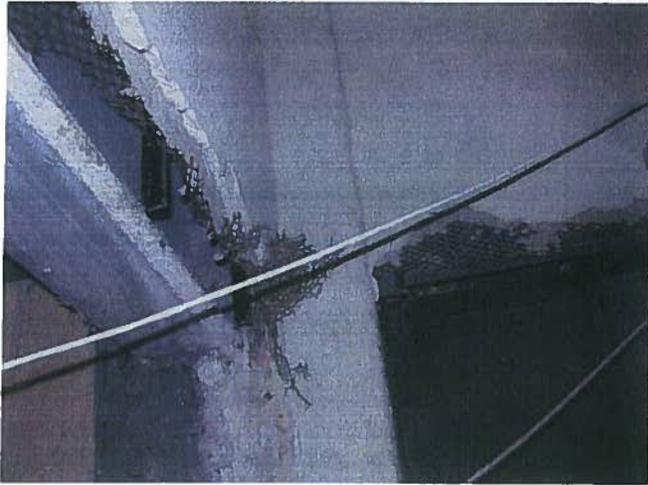
Photo No. 12:  
View damaged walls above the ceiling grid in Office E100. Similar damage to the walls were at various locations throughout the Ground Floor.

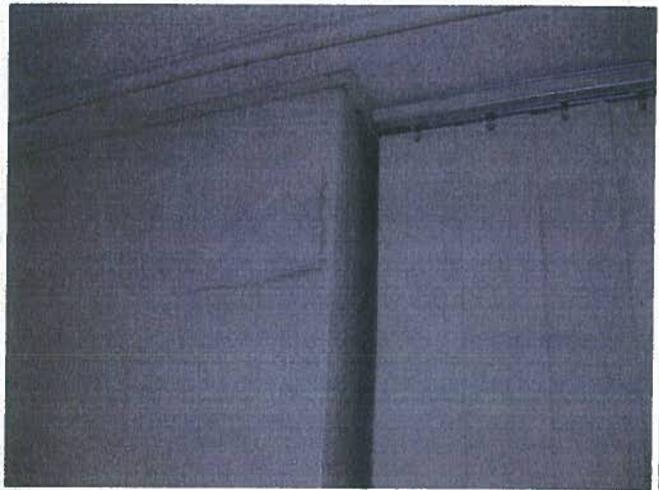
Photo No. 13:  
View of flaking paint in Office 101, north of Office 100. Similar flaking paint was observed at various locations throughout the Ground Floor.

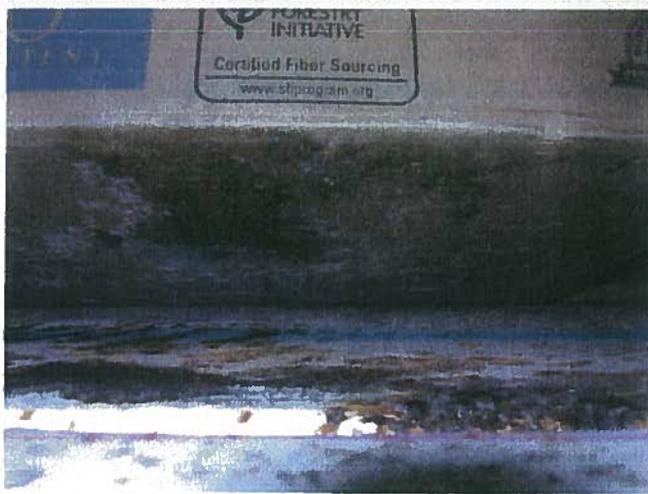
Photo No. 14:  
View indicating evidence of mold growth under a box on the refrigerator in Office 101.

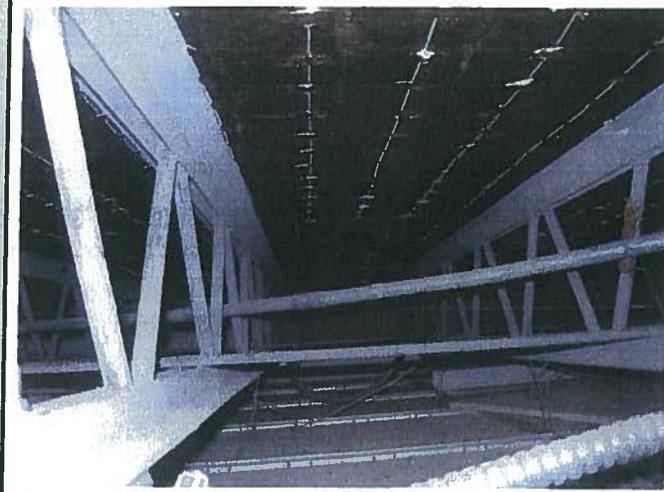
Photo No. 15:  
View of the ceiling above the above the suspended grid. Black felt was attached under the concrete ceiling, which extended throughout most of the Tax, Treasury and Purchasing area.

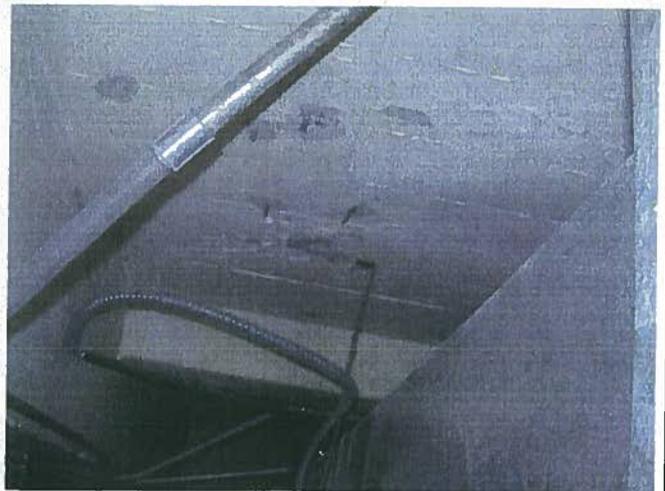
Photo No. 16:  
View of flaking paint on the ceiling and around anchors attached to the concrete. Similar flaking paint was found throughout various locations of the Ground floor.

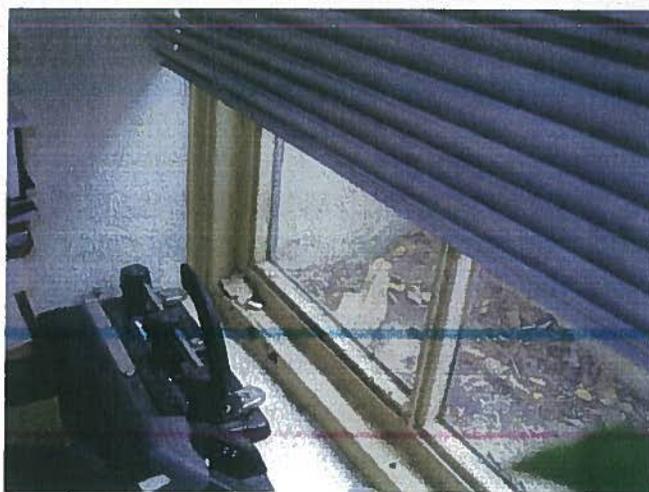
Photo No. 17:  
View of flaking paint around the window casing. Similar flaking paint was found around window casings at various locations throughout the Ground Floor.

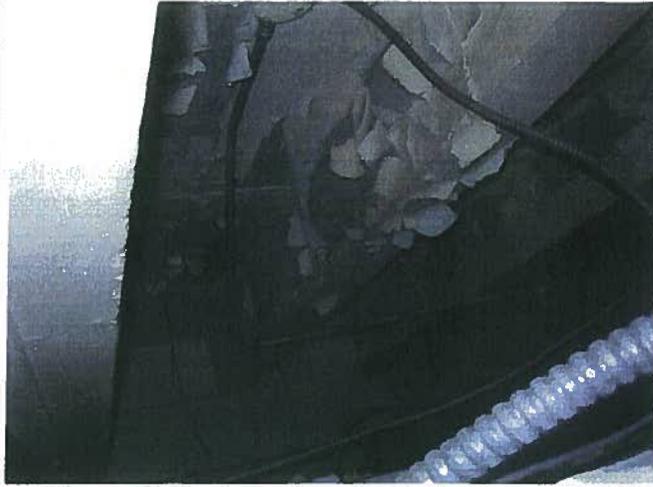
**Photo No. 18:**  
View of flaking paint on the ceiling above the suspended grid in Office 115-1A. Paint chips were on top of the ceiling tiles. Similar flaking paint was observed at various locations throughout the Ground Floor.

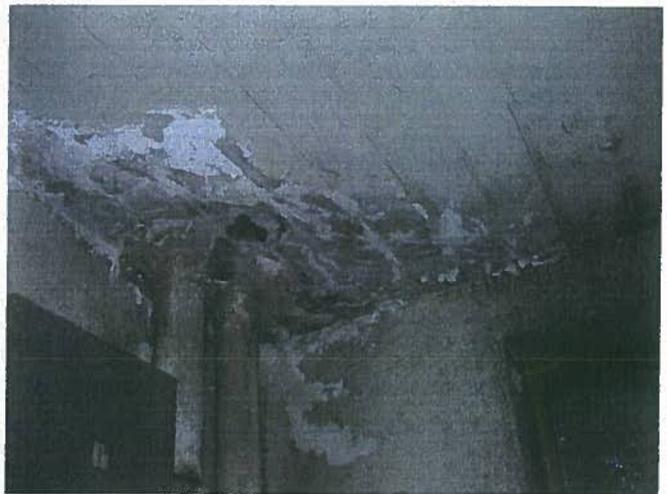
**Photo No.19:**  
View indicating evidence of mold growth and flaking paint in Room 115-10 (Air Handling Room) on the ceiling.

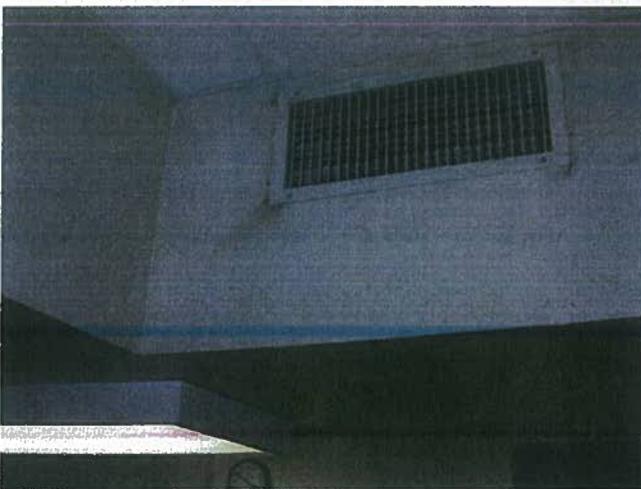
**Photo No. 20:**  
View indicating evidence of mold growth on the soffit for the air conditioning duct work. Similar mold growth was found on the ductwork throughout the Tax, Treasury and Purchasing area.

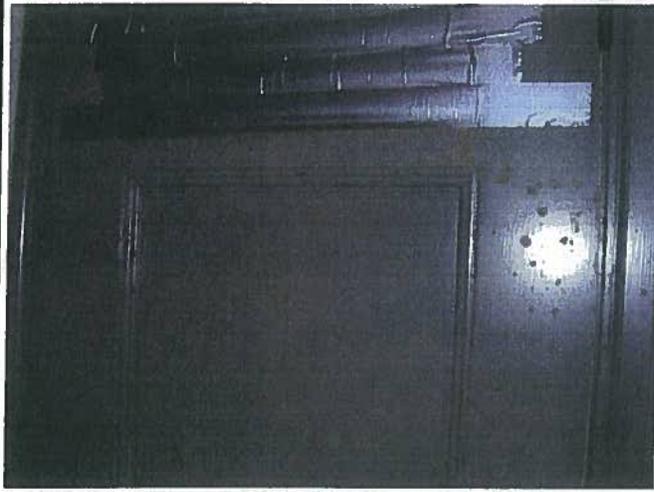
Photo No. 21:  
View indicating evidence of mold growth on the door to a storage room on the ground floor. Similar mold growth was observed at various locations throughout the Ground Floor.

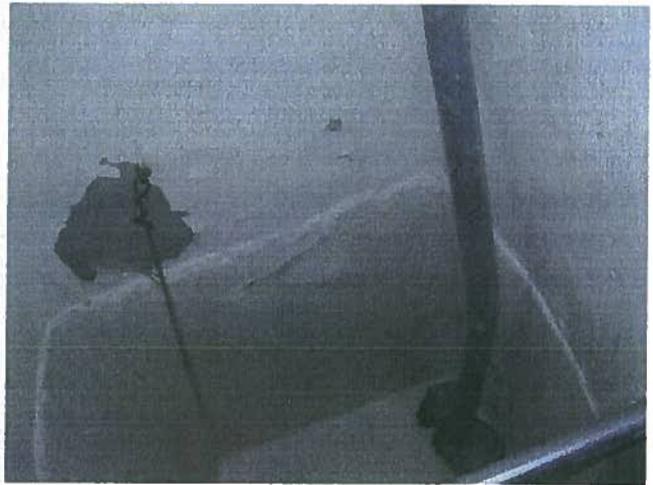
Photo No. 22:  
View of flaking paint on the concrete ceiling and around the anchor attached to the ceiling. Similar flaking paint was observed at various locations throughout the 2<sup>nd</sup> Floor.

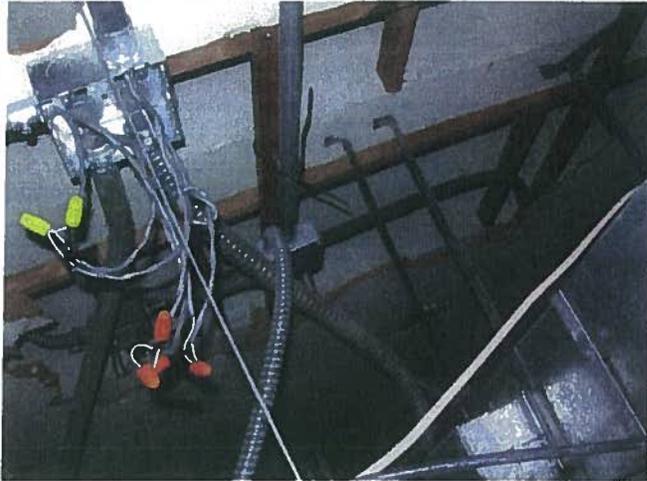
Photo No. 24:  
View of the damaged ceiling in Office M202 (Conference Room #2). Similar ceiling damage was in the offices along the southern side of the Counsel Member's Offices.

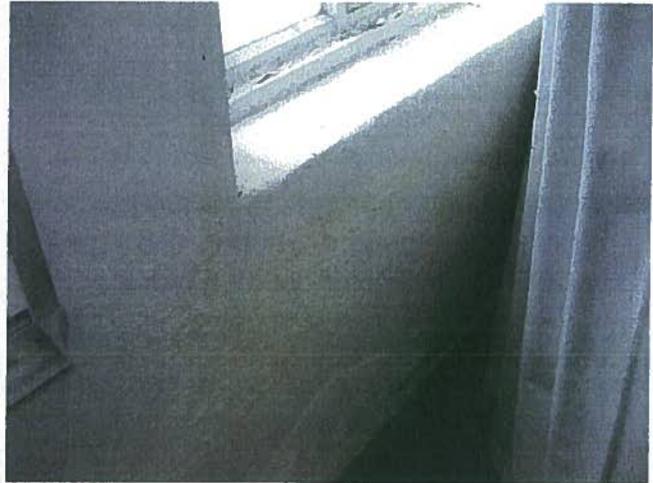
Photo No.25:  
View of flaking paint on the window sill and blistering paint on the wall below the window in Office 201-City Council Committee Meeting Room.

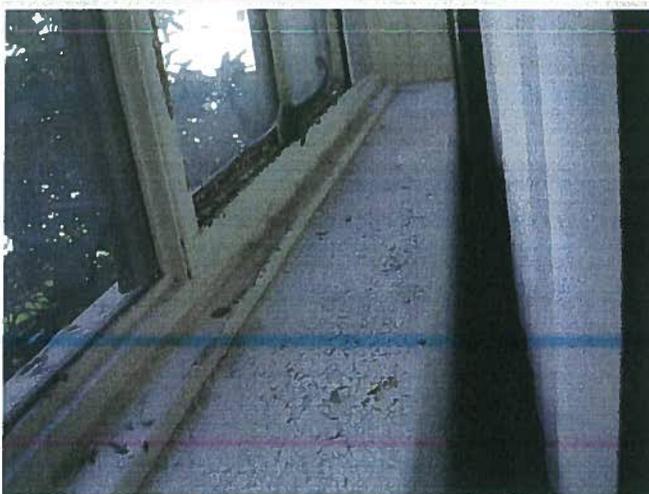
Photo No. 26:  
View of flaking paint on the window sill in the Council Services Office. Similar flaking paint was found on window sills at various locations throughout the 2<sup>nd</sup> Floor.

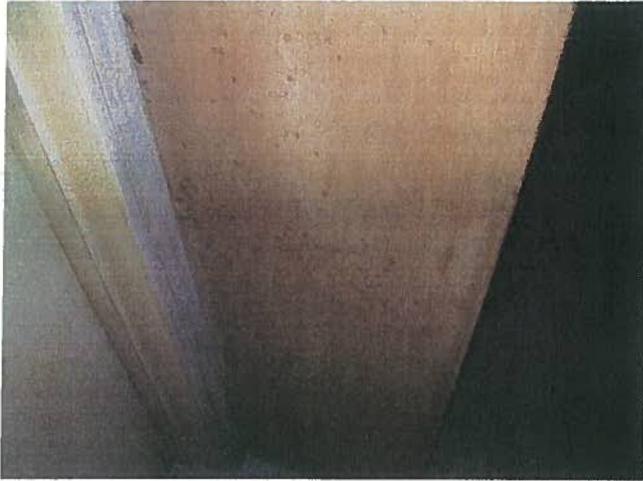
Photo No. 27:  
View indicating evidence of mold growth on the wooden shelf in the Council Services Office. Similar mold growth was observed at various locations throughout the 2<sup>nd</sup> Floor.

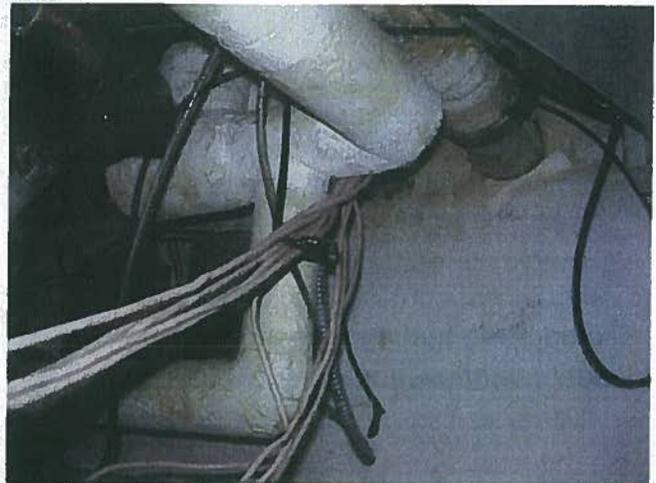
Photo No.28:  
View of staining on the gypsum wall and pipe insulation suggesting moisture intrusion or leaking occurred.

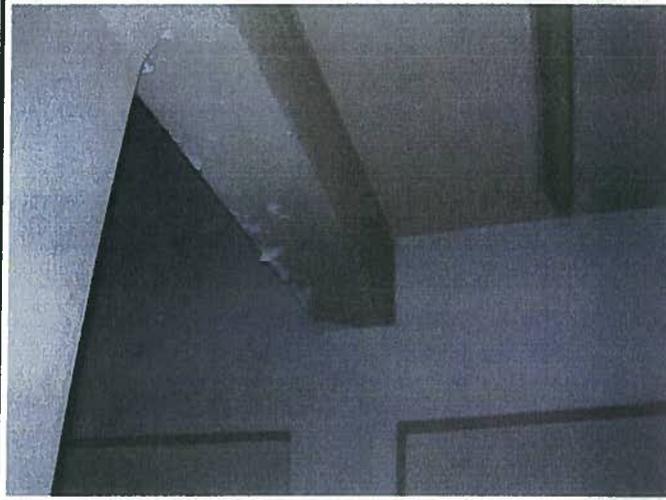
Photo No. 30:  
View of flaking paint on the ceiling in the 2<sup>nd</sup> Floor Hallway Stairwell. Similar flaking paint was observed at various locations throughout the 2<sup>nd</sup> Floor.

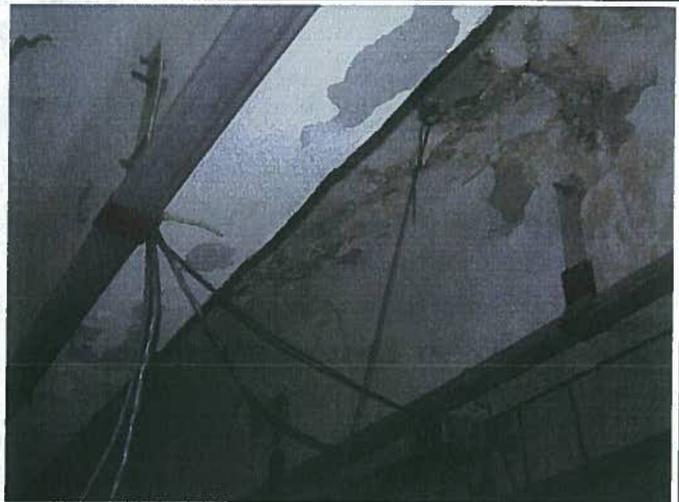
Photo No.31:  
View of the ceiling above the suspended grid in the Mayor's Small Office. The paint was flaking and staining suggested moisture intrusion or leaking occurred. Similar paint flaking and staining was at various locations throughout the 3<sup>rd</sup> Floor.

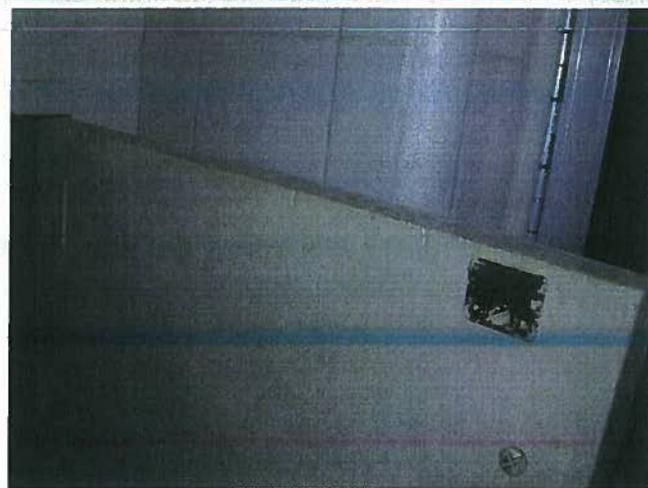
Photo No. 31:  
View indicating evidence of mold growth on the door in the bathroom. Similar mold growth was observed on doors at various locations on the 3<sup>rd</sup> Floor.

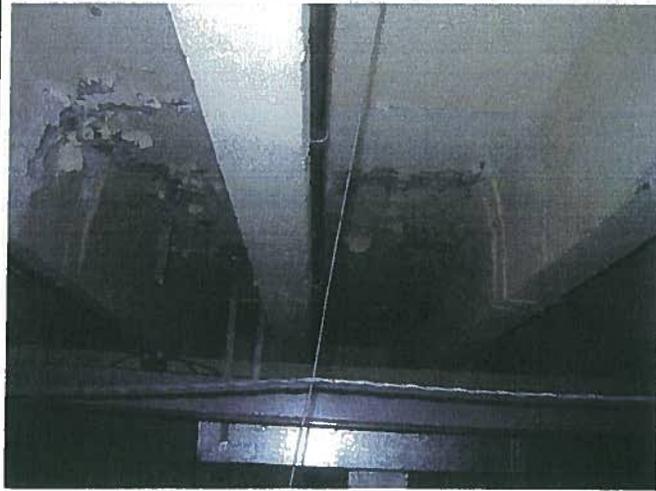
Photo No. 32:  
View of flaking paint on the ceiling in Office 301 (Conference Room). Paint chips were observed on the ceiling tiles. Similar flaking paint was observed at various locations throughout the 3<sup>rd</sup> Floor.

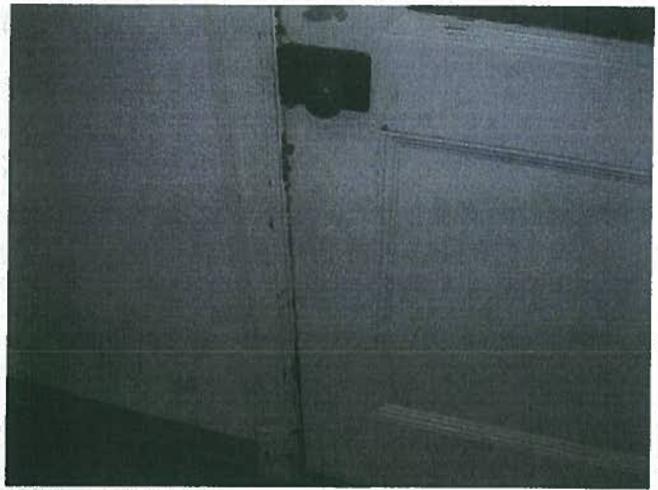
Photo No.33:  
View of deteriorated paint at the friction points of the door and doorframe. Similar deteriorated paint was observed at various locations throughout the 3<sup>rd</sup> Floor.

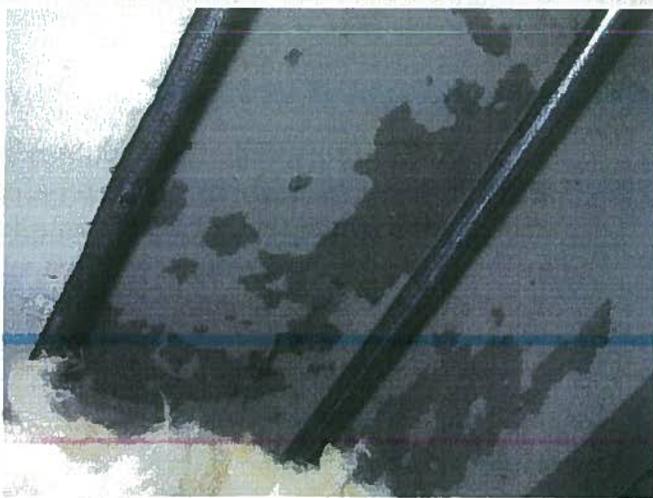
Photo No. 34:  
View the paint on the ceiling in the renovated offices on the 3<sup>rd</sup> Floor. The loose and flaking paint was removed prior to renovations .

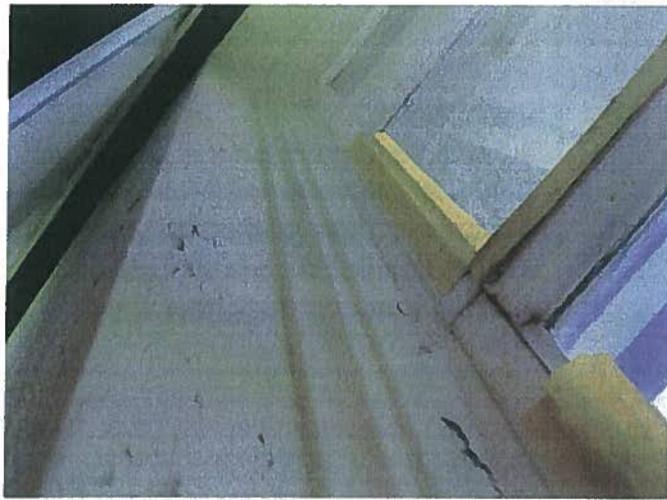
Photo No. 35:  
View of a flaking paint on a window sill in the Budget and Fiscal Office on the 3<sup>rd</sup> Floor. Similar flaking paint was observed at various locations on the 3<sup>rd</sup> Floor.

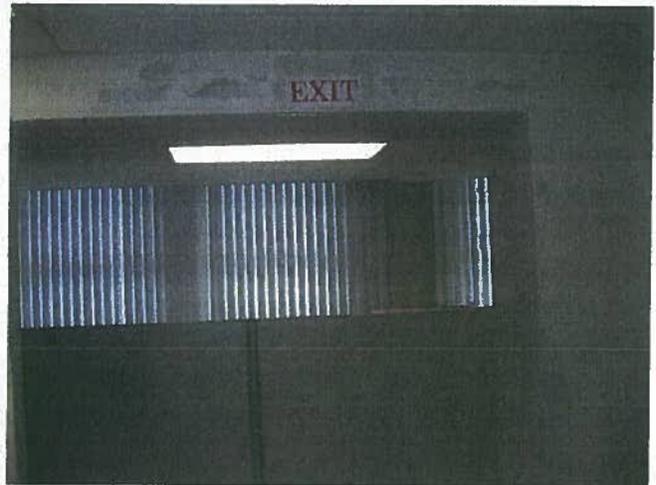
Photo No.36:  
View of flaking paint on a wall in the Budget and Fiscal Office. Similar flaking paint was observed at various locations on the 3<sup>rd</sup> Floor.

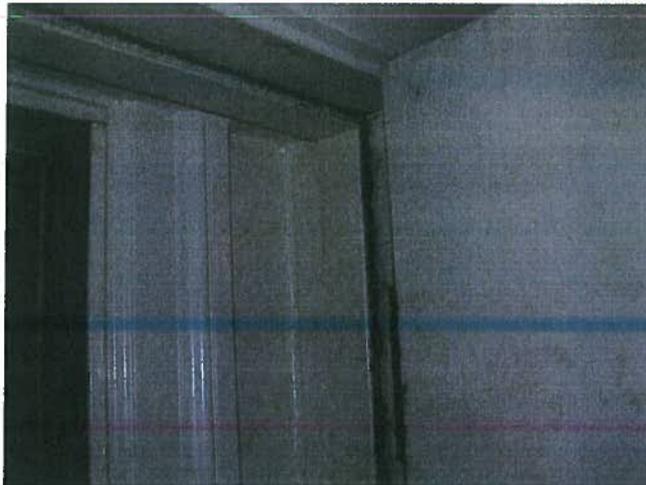
Photo No. 37:  
View indicating evidence of mold growth was on the walls, door and doorframe in the Budget and Fiscal Office entrance to their bathroom. Similar mold growth was observed in the bathroom and other areas of the 3<sup>rd</sup> Floor.

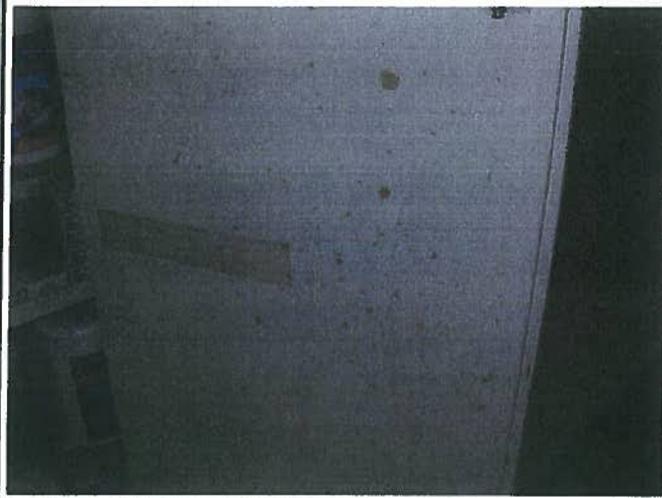
**Photo No. 38:**  
View indicating evidence of mold growth on the wooden cabinets in the 3<sup>rd</sup> Floor Budget and Fiscal Office. Similar mold growth was located at various locations throughout the 3<sup>rd</sup> Floor.

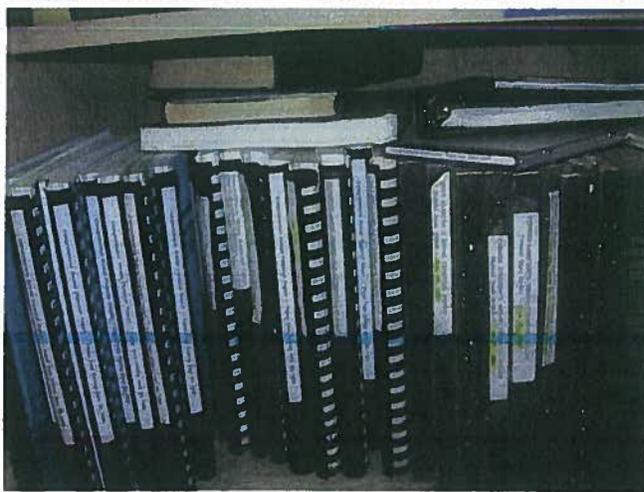
**Photo No. 40:**  
View indicating evidence of mold growth impacting books on a shelf in the copy room of the Budget and Fiscal Office. According to occupants, leaking occurred in the Copy Room.

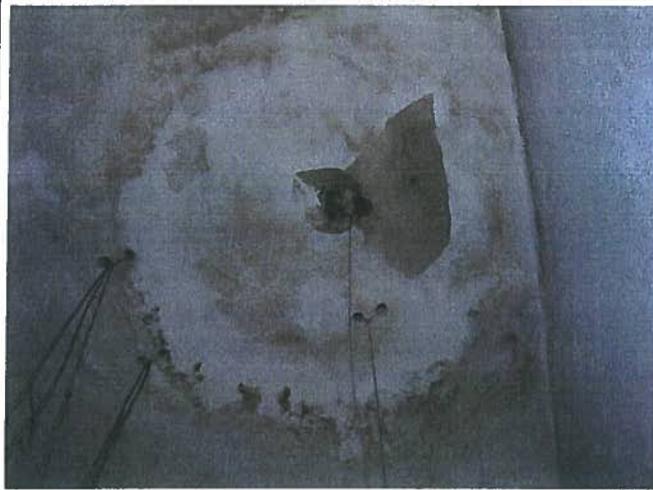
**Photo No. 41:**  
View of staining on the ceiling in Office 401. Staining suggested moisture intrusion or leaking occurred, which may have loosened the paint. Similar leaking was observed at other locations of the 4<sup>th</sup> Floor.

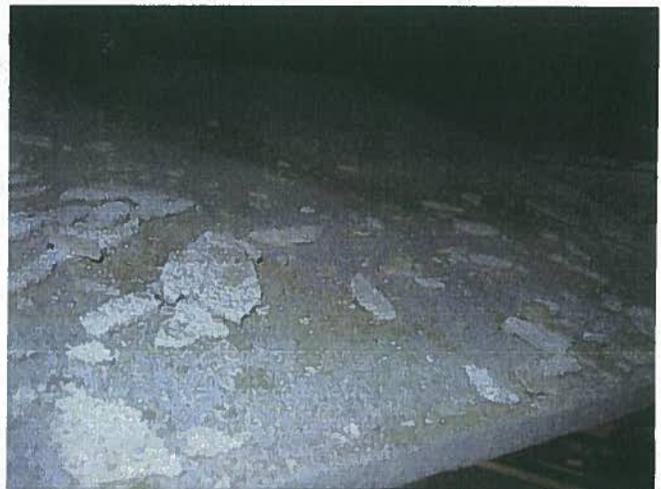
**Photo No.42:**  
View of painted ceiling debris on the ceiling tiles in Office 401. Similar debris from the ceiling was observed in the Office 401 and 402.

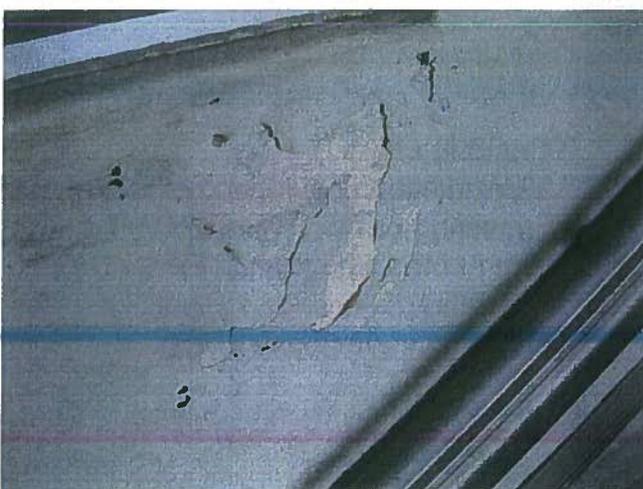
**Photo No. 43:**  
View of flaking paint on the wall in the hallway fronting Offices 402 and 403.

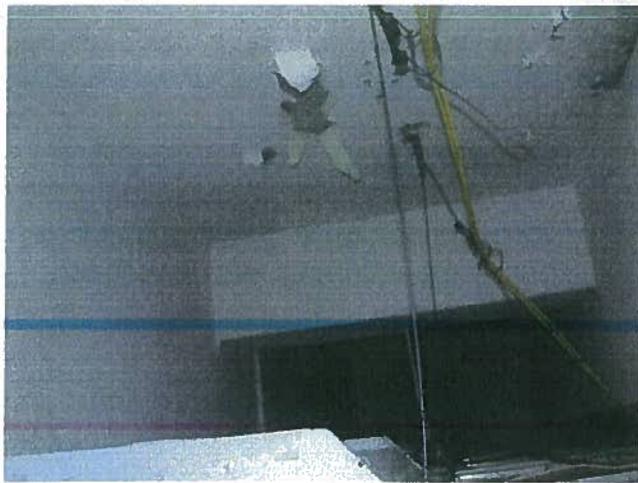
Photo No. 46:  
View of flaking paint on the ceiling above the suspended grid in Office 501. Similar flaking paint was observed at various locations in the office.

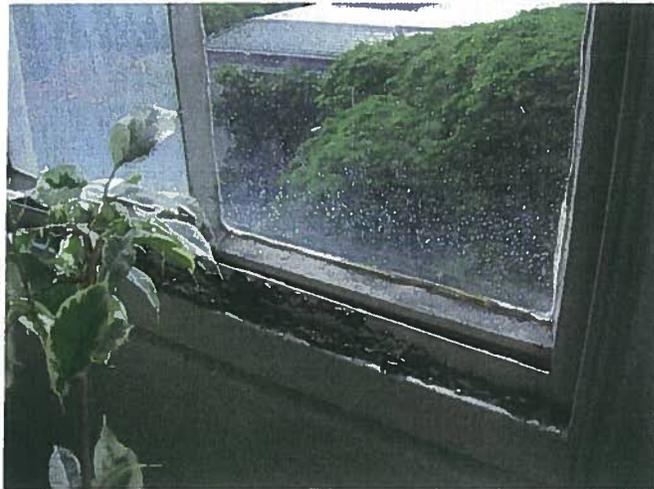
**Photo No. 47:**  
View of flaking paint and rusting on the window casing in Office 601. Similar flaking paint and evidence of rust on the casing was observed on the other window casings in the office.

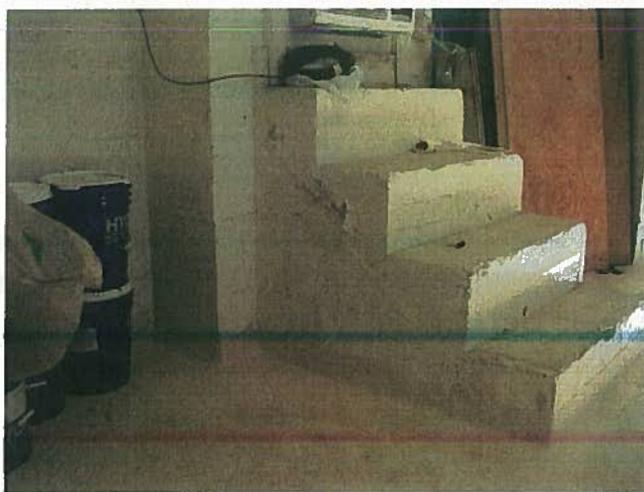
**Photo No. 49:**  
View of flaking paint on stairs in the 8<sup>th</sup> Floor Office. Similar flaking paint was observed at various locations in the office.
