SUBJECT: LEAD RISK ASSESSMENT AND MOLD  
SURVEY FOR HONOLULU HALE

The enclosed subject report, dated February 24, 2012, prepared by Muranaka Environmental Consultants, Inc., has been accomplished and is transmitted for your information and use. This report does not include the Department of the Corporation Counsel which was covered in a separate report.

Photo Log  
Honolulu Hale  
Lead Paint Risk Assessment and Mold Investigation  
MEC Project No.: 2011-0044  
July 2011

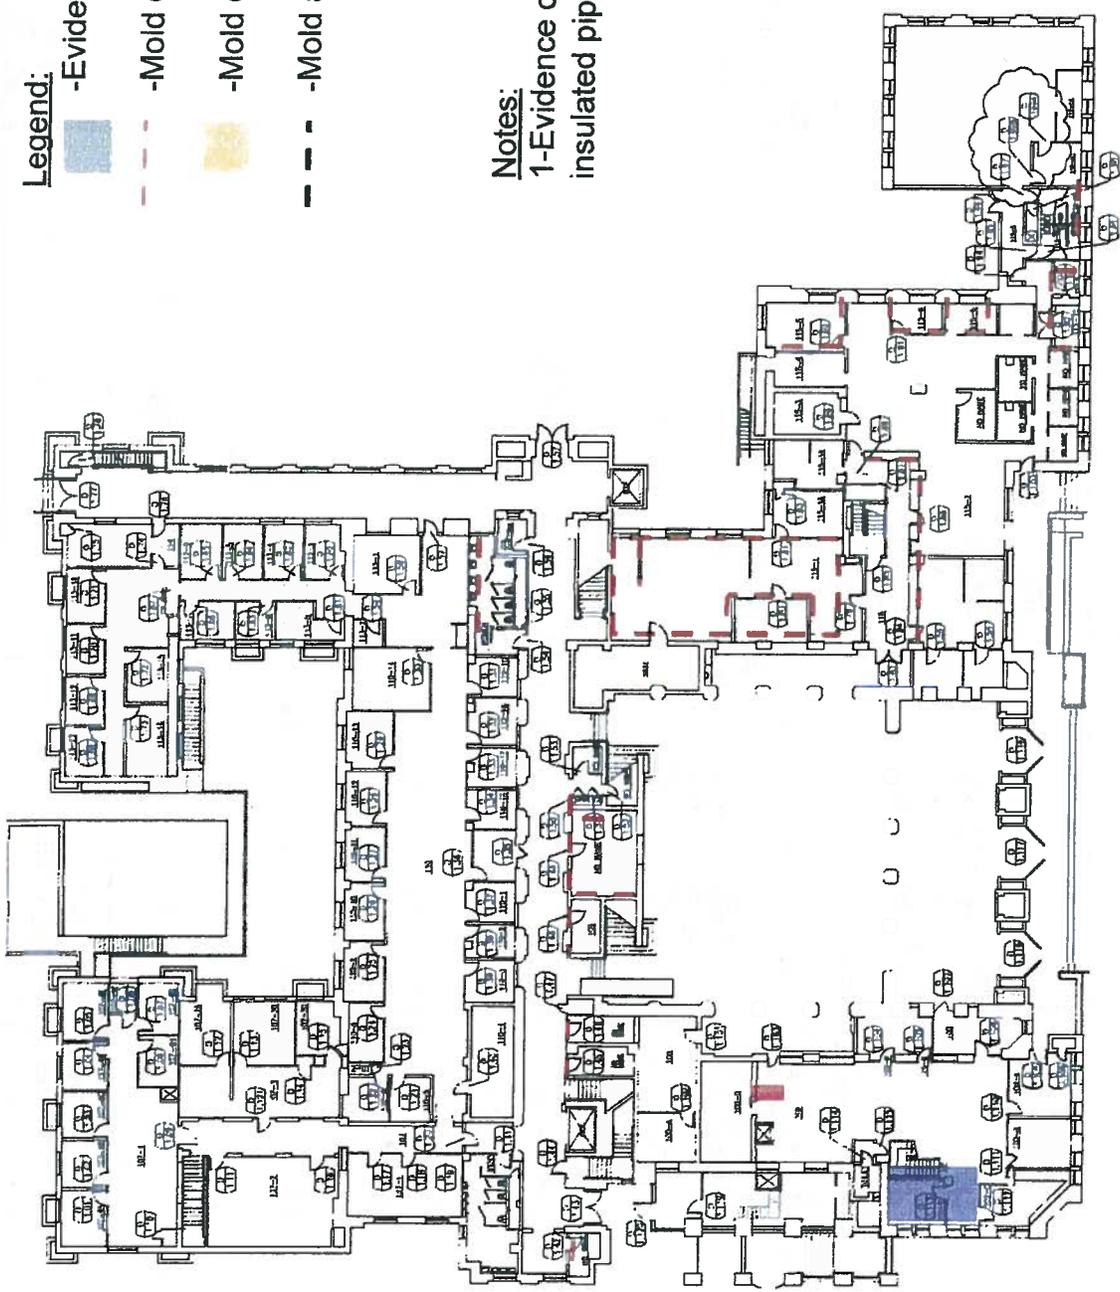
**Ground Floor Plan**

- Evidence of Moisture Intrusion
- Mold on the Walls, Wooden Cabinets
- Mold on the Ceilings
- Mold above the Ceiling Grid

1-Evidence of moisture was found on the insulated piping throughout the area.

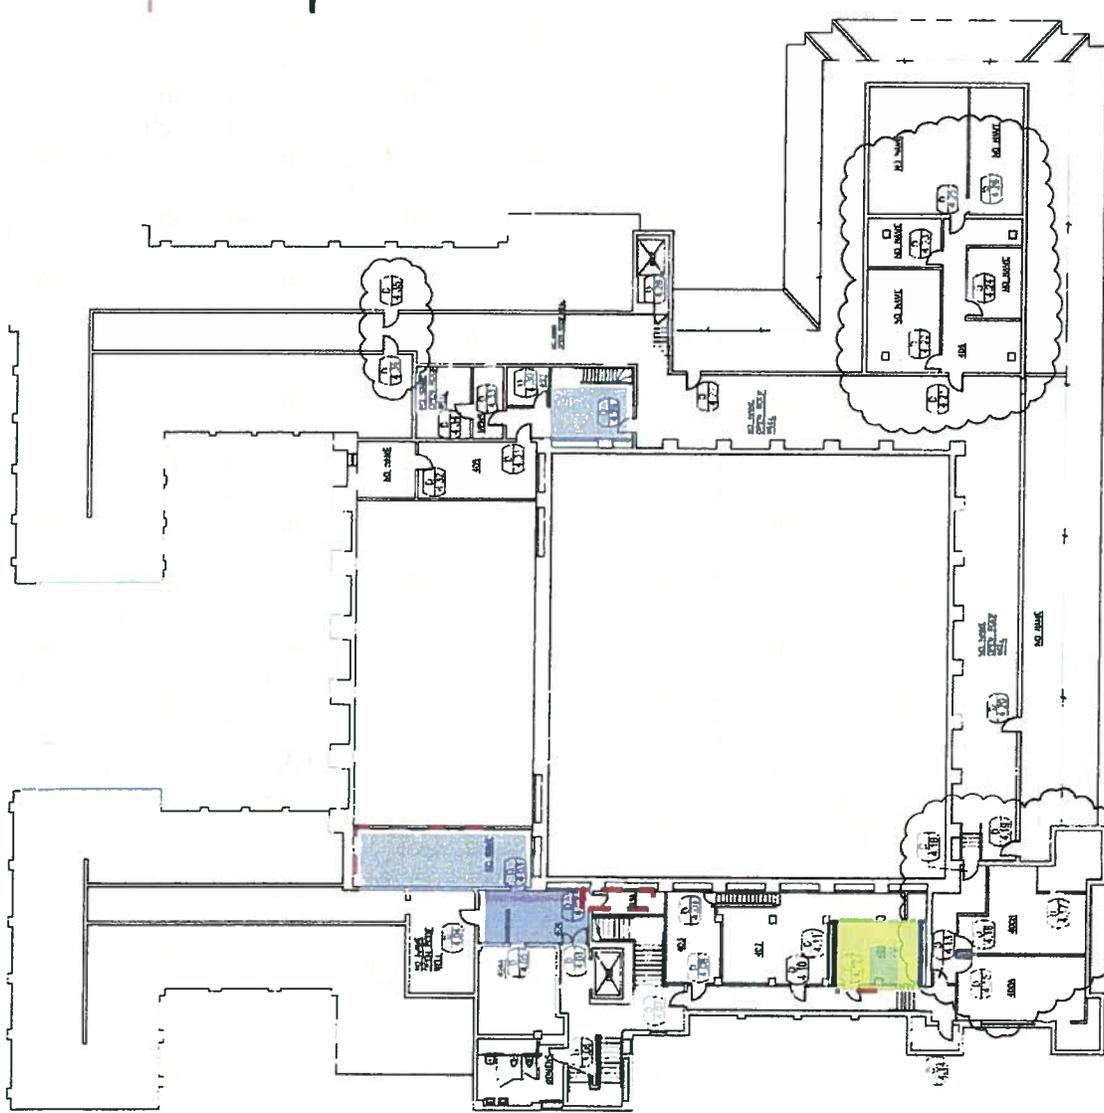
### 4th Floor Plan

-Evidence of Moisture Intrusion

-Mold on the Ceilings

-Mold above the Ceiling Grid

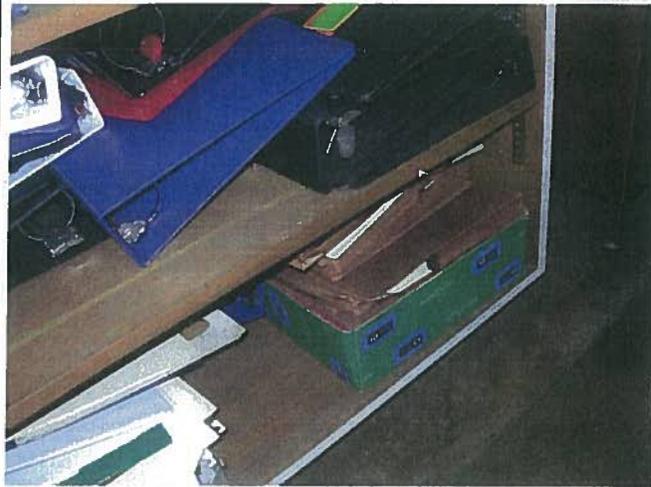
Photo No. 44:  
Evidence of mold growth indicated by the gray patches on the binders and wooden shelving, located in the Culture and Arts Office.

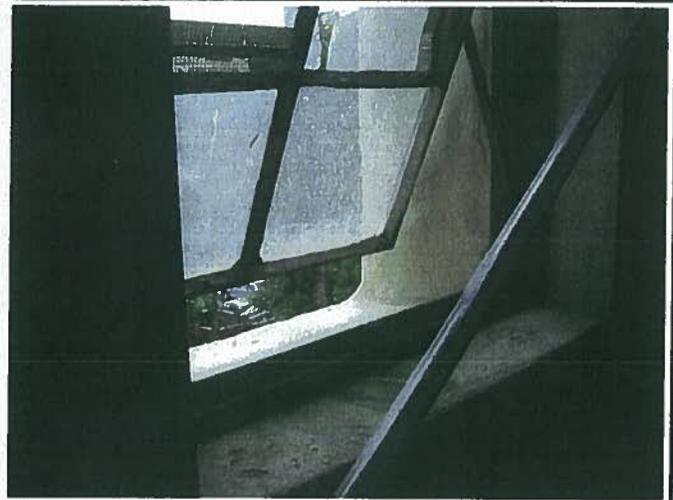
Photo No.45:  
View of the flaking paint on the window sill in the common area fronting the Culture and Arts Office.
