Photo Log

ADA Curb Ramp Recommendations Form

WILSON OKAMOTO & ASSOCIATES, INC.
ENGINEERS • PLANNERS

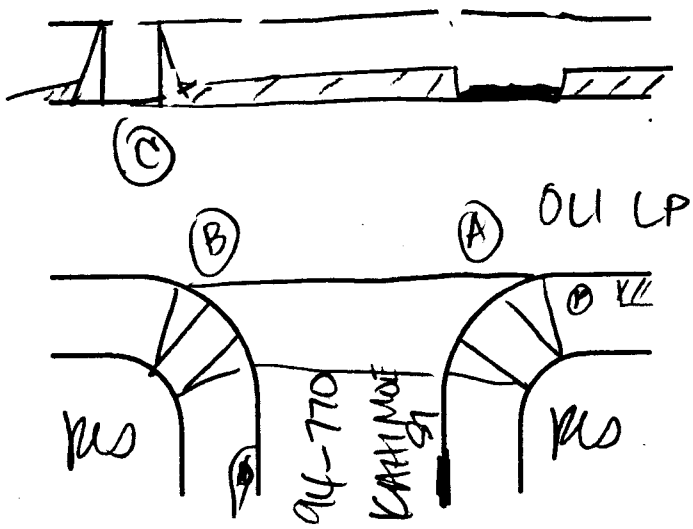
Cross streets: 94-770 KAHINDE ST / OLI LP
Intersection #: 9C0809
Date: 3/12/98

Element	Severity	Item #1	Item #2	Item #3	Item #4	Item #5	Item #6	Item #7	Remarks
A	PSH	0304AJ							J=2.0
B	PSH	0304AJ	0408G						↓
C	PSH	0202G	0303G	0501G	0408G	0414S			↓
D									
E									
F									
G									
H									
I									
J									
K									
L
